# Conservation Area Appraisal

## Old Cassop

December 2009

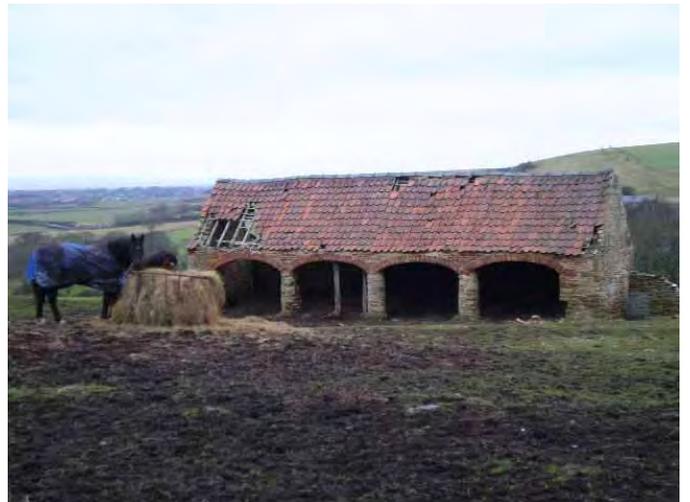
Historically development came right upto this point on both sides of the road. Historical maps suggest that the north side contained a range of farm buildings that belonged to Cassop Hall. All that remains of these are various marks in the ground and one **single-storey cart shed**. The cart shed is of sandstone construction with some brick repairs and has a red pantile roof.

It is a significant part of the view north and as a reminder of the now lost farmstead. Unfortunately the building has been left to decay and in desperate need of repair.

**Fig 4: The single-storey cart shed, a historic building demarcating the main entrance into the village.**

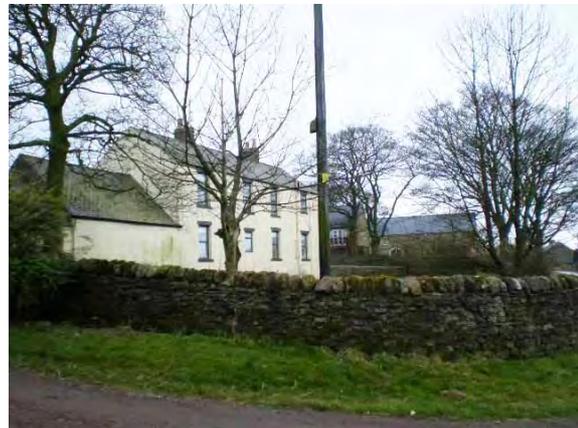
Opposite the cart shed and marking the eastern entrance of the village is **Grange Farm**. Located on a slight rise and set back from the roadside this large two-storey farmhouse makes a strong impression. It is constructed in stone with a slate roof. The name 'Grange' can often denote the centre of a farm belonging to a Church and this suggests a link between the farm to the Prince Bishops that could go back to its foundation. The age of the farmhouse is difficult to assess accurately as windows, chimney stacks and doors have been replaced and the front elevation covered in render. However the arrangement of windows and

doors strongly suggests that it was once a 'cross passage house' where living and service rooms were divided by a passageway that ran across the depth of the property. Considering this a likely date for Grange Farm would be late 18th century to mid 19th century.

**Fig 5: Grange Farm set back from the street frontage behind a large garden and rubble stone wall.**

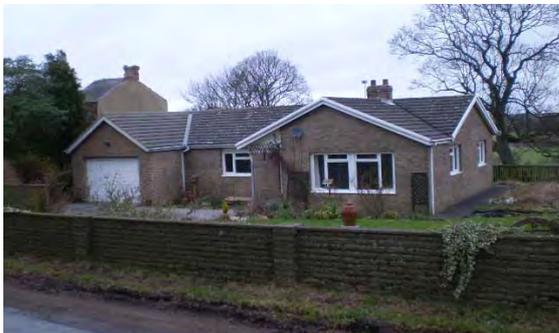
Diagonally opposite Grange Farm is **Tunstall Cottage**, a late 20th century bungalow set within a neat garden and in front of a back drop of mature trees. This building is not of any historical or architectural interest, though its simple design and garden help it to blend with its surroundings.

**Fig 6: Tunstall Cottage a modern bungalow facing Grange Farm.**

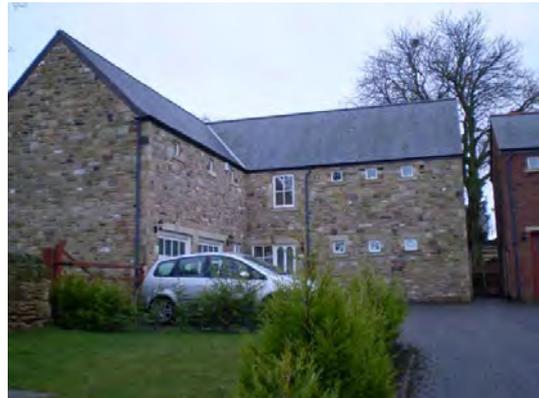
The 2001 development of **1 to 3 Oak Rise**, has clearly tried to reflect the rural character of the conservation area through a design influenced by farm buildings.

In this respect the development is successful though the overall

effect is lessened by the scale of the buildings which by contrast to the rest of the village, is too large to be placed in such close proximity.

**Fig 7: The Orchard immediately to the west of Oak Rise, a modern development with traditional aspects.**

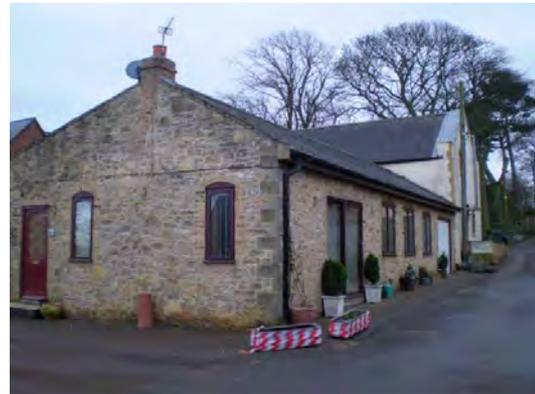
The earliest conversion dating from the 1980s occupies the eastern side of the track and consists of **Cassop Farm Bungalow**, a single storey stone building running parallel to the track which then meets a two-storey farm building, **The Cottage**, that was originally of stone but is now rendered.

Cassop Farm Bungalow has been converted without too many alterations and retains a semblance of its original character. By contrast The Cottage has been heavily altered externally with render, fake-stone quoins and chimneys. Consequently the building retains little of its agricultural past and has a domestic character.

**Fig 9: Cassop Farm Bungalow a former barn with a prominent gable facing the roadside marking the entrance into the older farmstead.**

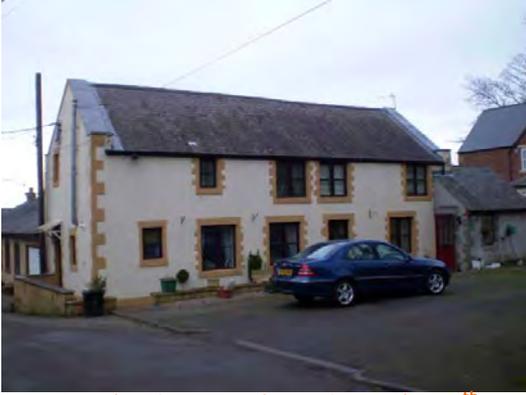
**Fig 10: The Cottage dates from the 19<sup>th</sup> century, a former hey barn now much altered and in residential use.**

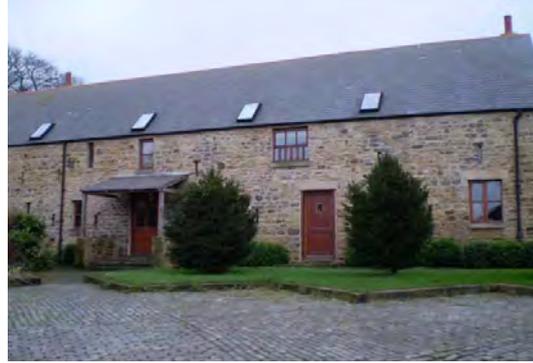
The buildings on the west of the track are a mix of new buildings and conversions. **Strawberry Hill Barn and Blue Barn** are impressive and imposing former barns that could have been a hay barn later converted to a byre. Its conversion has been sensitively achieved and its history can still be read.

**Fig 11: Strawberry Hill Barn and Blue Barn, two former long narrow barns of a mid 19<sup>th</sup> century date, retaining much of their original character.**

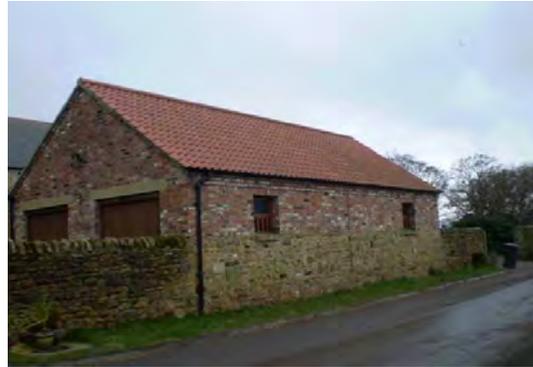
In front of it is a brick garage that replaced a similar size brick structure dating from the first half of the 20<sup>th</sup> century. Enclosing it and fronting the Main Street is a rebuilt stone wall. Behind Strawberry Hill Barn is **Swallow Ridge Barn** which is largely a modern building that appears to incorporate parts of a traditional stone barn in its eastern side.

**Fig 12: The detached double garage is of a traditional appearance and has been constructed from materials salvaged from the original barns.**

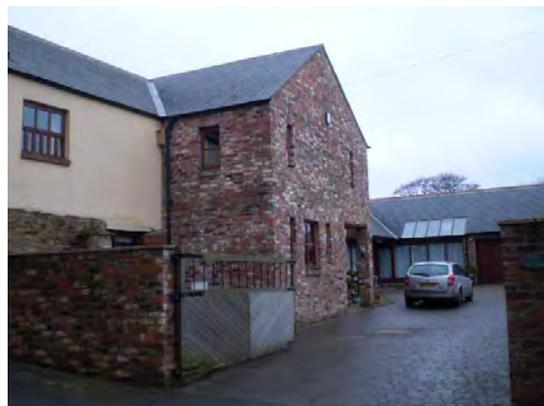
**Fig 13: Swallow Ridge Barn constructed in the late 20<sup>th</sup> century incorporating part of an early grannery/cartshed dating from the mid 1800's.**

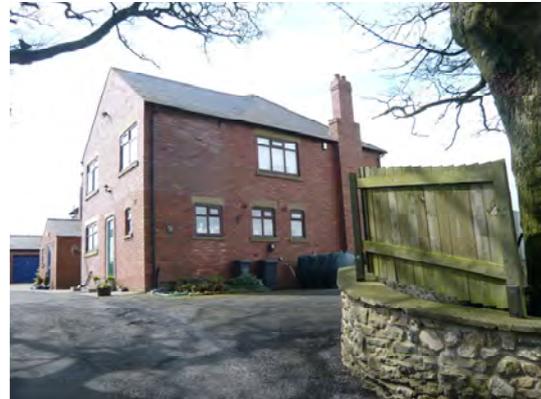
Continuing up the track between these buildings leads up a gradual rise to **Cassop Farm House** and **Hill Crest** a pair of brick semi-detached houses dating from the 1950s. These are substantial buildings designed in a simple solid style that compliments the general style of houses within the village.

**Fig 14: Cassop Farm House and Hill Crest although of a mid 20<sup>th</sup> century date these properties have a more traditional appearance sympathetic to their setting.**

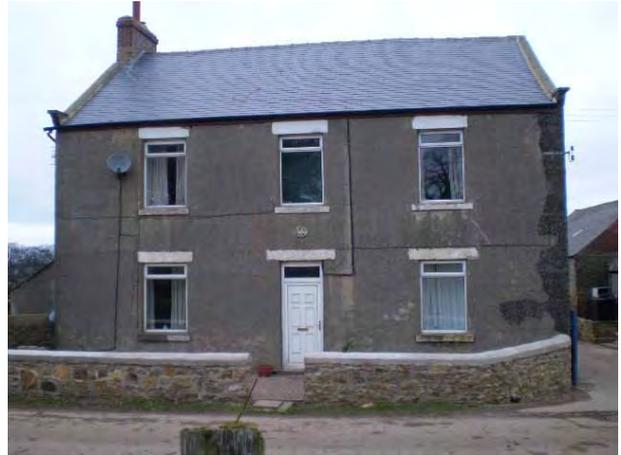
Back along the village on the northern side of road and at the western extent of the village is Pilmore Farm and Hill Croft. **Pilmore Farm** is the most complete historic farm within the village. It consists of a farmhouse fronting the road with a range of historic stone and modern farm buildings arranged in an irregular courtyard behind and to the side of the main house. A large modern Dutch barn and two modern farm buildings are located east of this group.

**Fig 15: Pilmore Farmhouse a late 19<sup>th</sup> century detached farmhouse marking the entrance into the farmyard.**

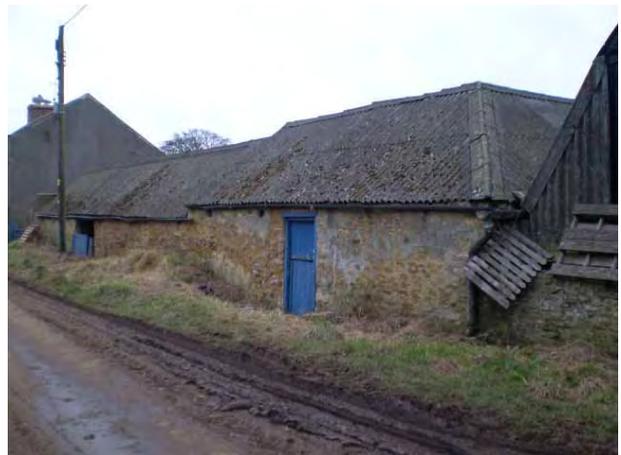
**Fig 16: Pilmore Farm's early/mid 19<sup>th</sup> century Cow House.**

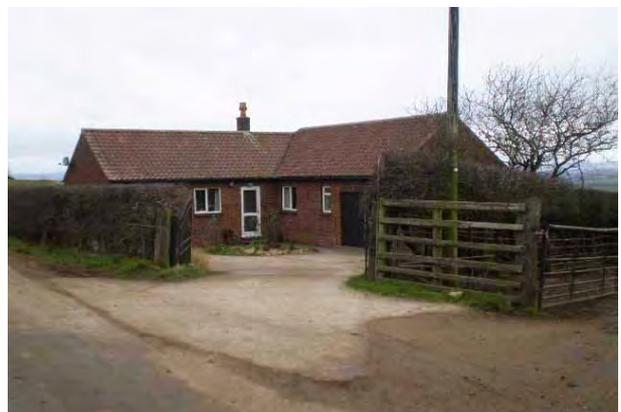
**Hill Croft** marks the western end of the village. It is a 'L'-shaped red brick bungalow with pantile roof and plastic windows and doors. The property is slightly hidden by a high mature hedgerow enclosing the driveway and garden space.

**Fig 17: Hill Croft a modern red brick bungalow.**
