Vinovia

[THE BINCHESTER BULLETIN] ISSUE NUMBER 11 [June 2013]

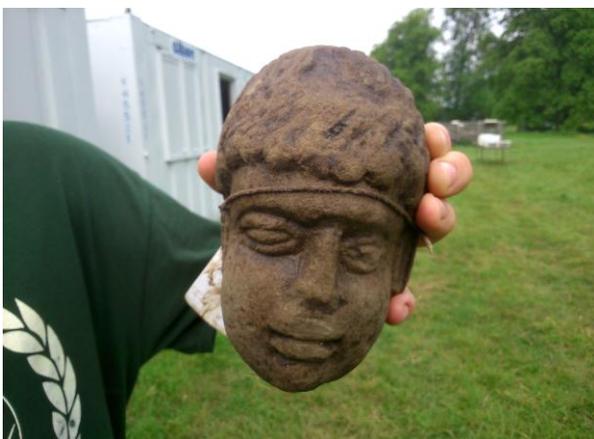
The picture shows the head of a statue recovered from trench 2. It probably depicts a local Romano-Celtic deity.
