CONSERVATION AREA APPRAISAL

Crook

December 2013

Heritage, Landscape and Design
Durham County Council

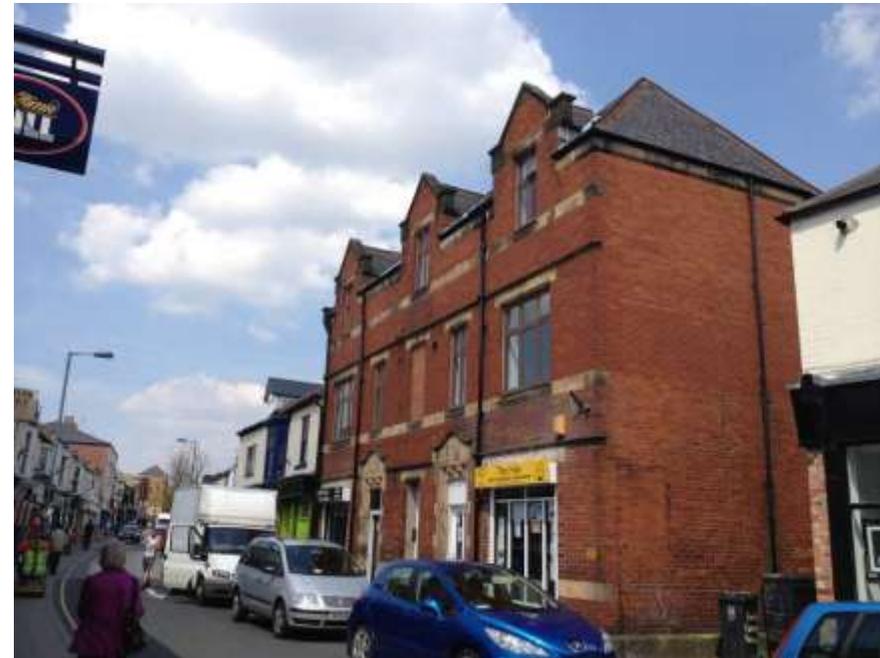
Old Police Station, bottom of Hope Street

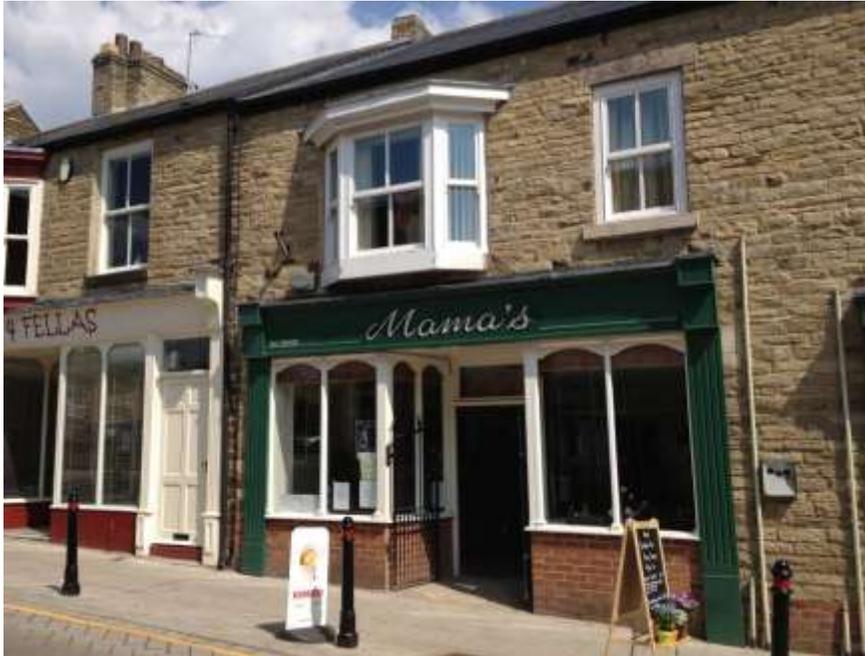
Traditional shop front detail, Hope Street

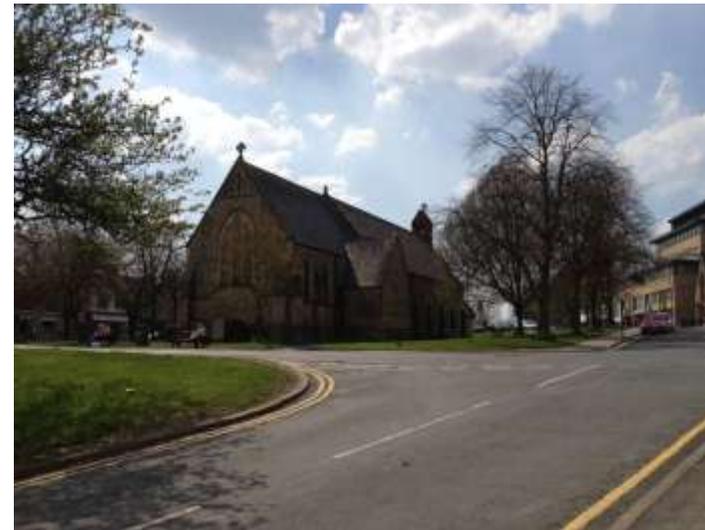
St Catherine's Church, The Green

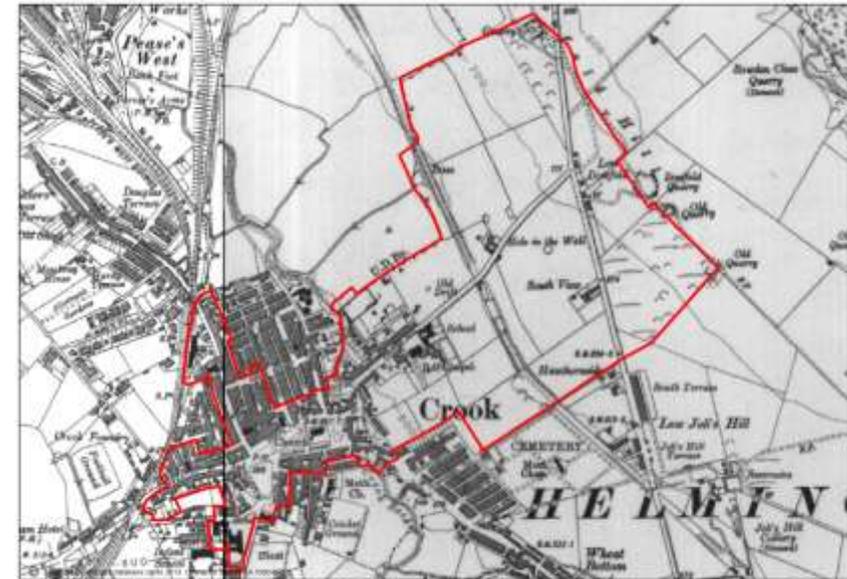
1923 OS extract

By 1923 the plan form of the town which now forms the basis of the conservation area was established. Although slightly outside the now defined area, social and cultural facilities associated with a thriving town had also been established including the football ground and a cricket ground. Residential development had also begun to expand north of the station as more land was required.

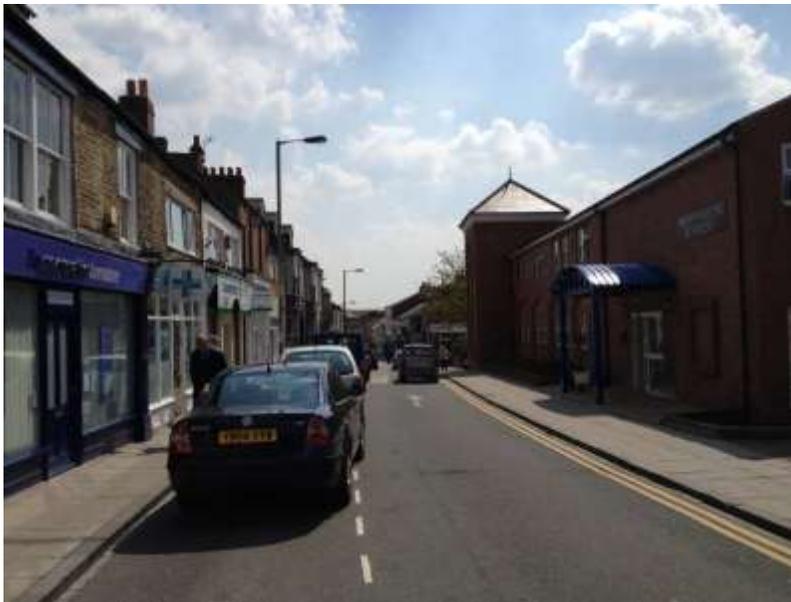
Top of Hope Street

This street contains many small shops and several pubs. Most of the smaller shops are well maintained and are in good decorative order, structurally sound and form continuous frontages along the street. There are however some vacant units and some buildings in need of repair. Generally the buildings are two storeys in height, constructed in stone with slate roofs. Others are rendered and several are of brick including the former Police Station. Many of the smaller buildings have oriel windows in the upper storey and original or sympathetic replaced timber shop fronts. The properties at the lower end of the street have colour washes on the upper storey walls, where as random or coursed rubble stonework remains visible on those properties at the upper end of the street.

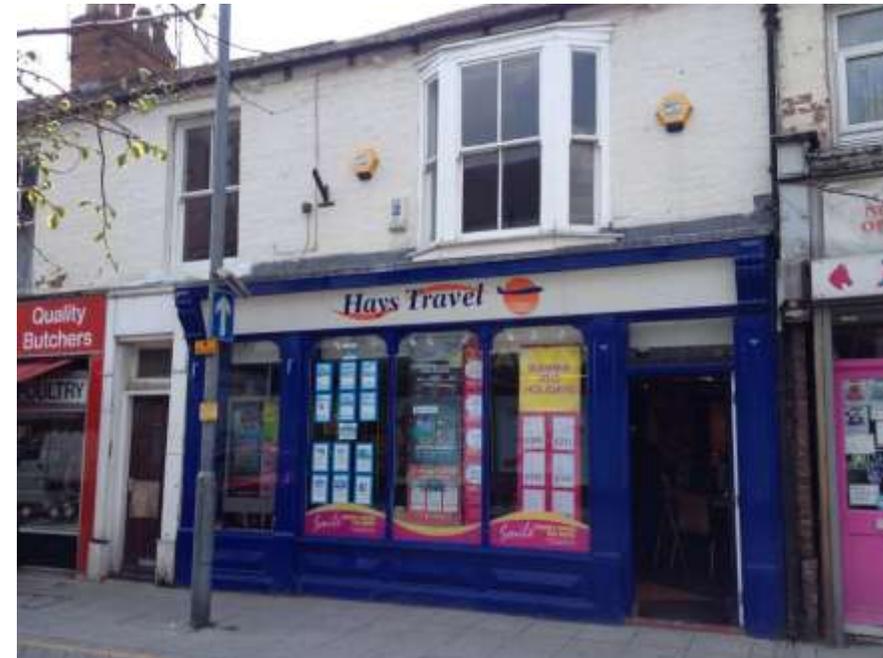
Shop Front on Hope Street

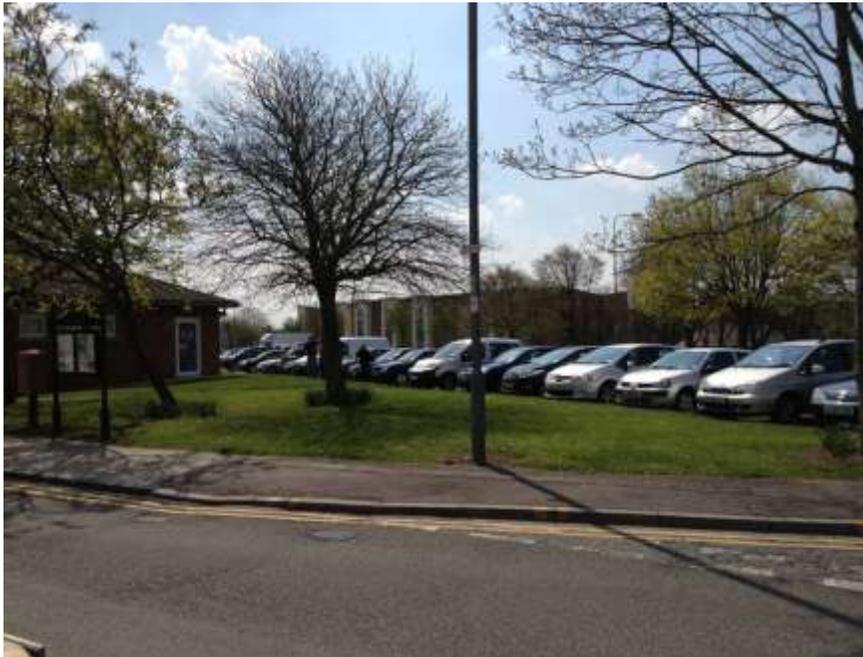
Demolition of buildings in Hope Street has reduced the enclosed nature of the street. The opening up of this space has also contributed adversely to the microclimate of the street, which now has an open northerly aspect.

Car park at top of Hope Street, site of demolished station

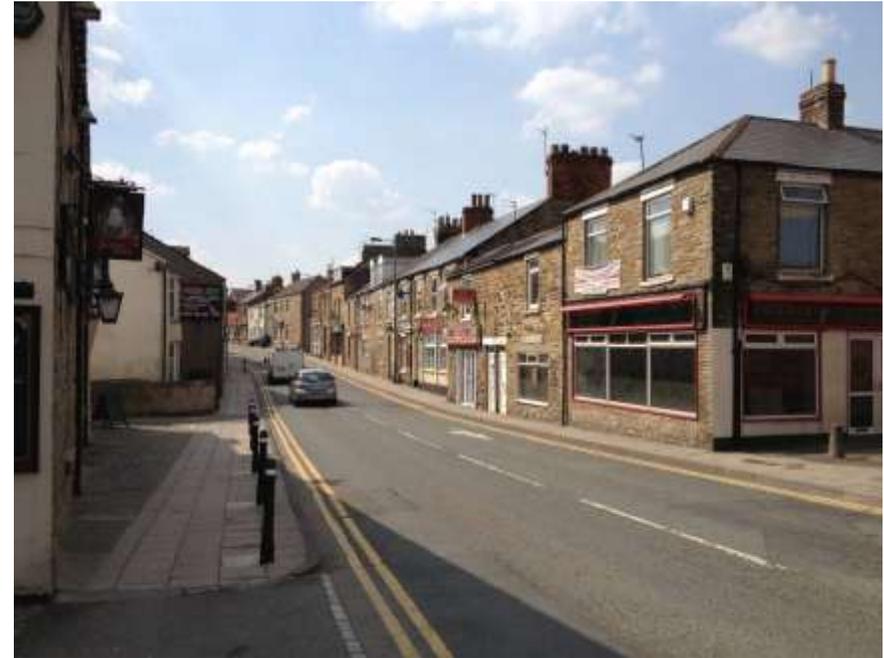
Northern side of Commercial Street

Commercial Street forms the western most limb of the conservation area. The southern side of the street is occupied by shops, offices and public houses. The properties to the eastern end of this frontage are stepped back from the road. The northern side of the street has several shops, residential properties and a club set back from the road. It is part of the A689 and suffers heavy traffic which is exacerbated by the lack of rear access to shops and offices.

Generally the buildings are two storey, stone/rubble, terraced properties dating from the mid 19th century. No. 15 is a fine example of a dressed rubble wall construction with brick

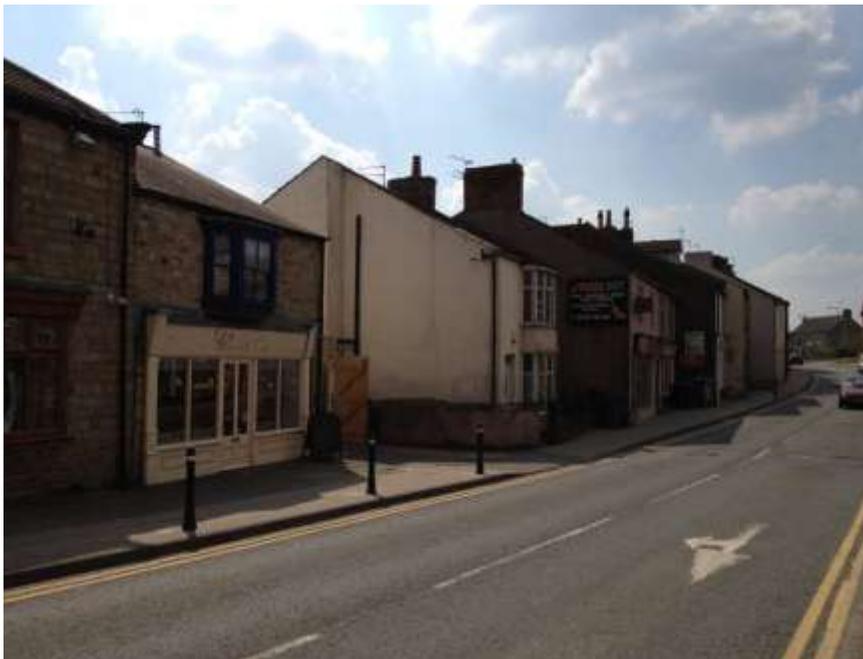
Southern side of Commercial Street

The western junction of the street where it forms a junction with the B6299 is visually bleak. Due to sight lines and the design adopted, the area is very open with large grassed areas and little visual relief. The club courtyard is a poorly maintained space which would benefit from sympathetic treatment including the rationalisation of the car parking spaces. The floorscape of the street is poor; pavements are cracked and where access streets have been closed off the treatment is indifferent.

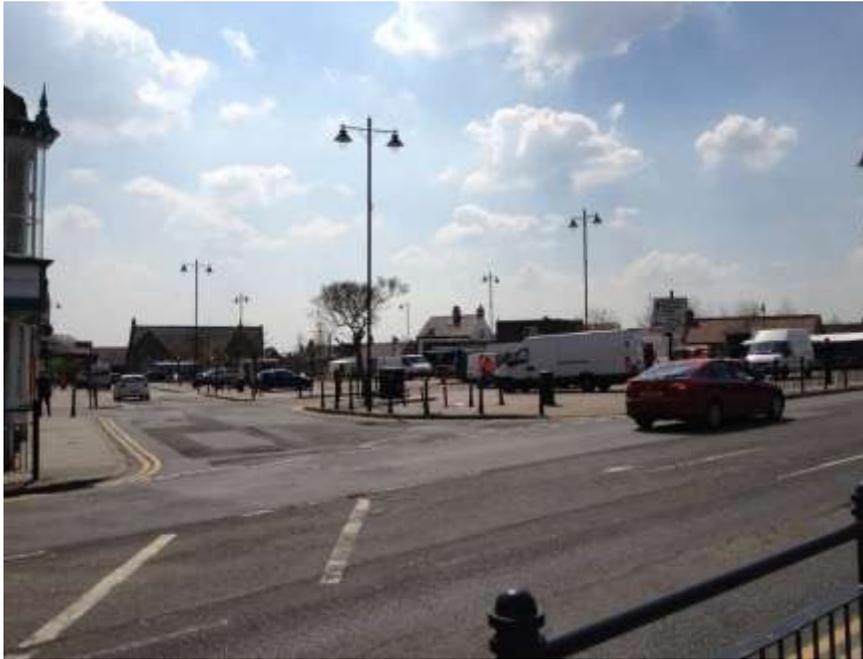
View southwards of Market Place

The buildings which surround the market place are generally inappropriate to their setting and fail to enclose the market area. The variety of building type and materials used means that few buildings relate to one another.

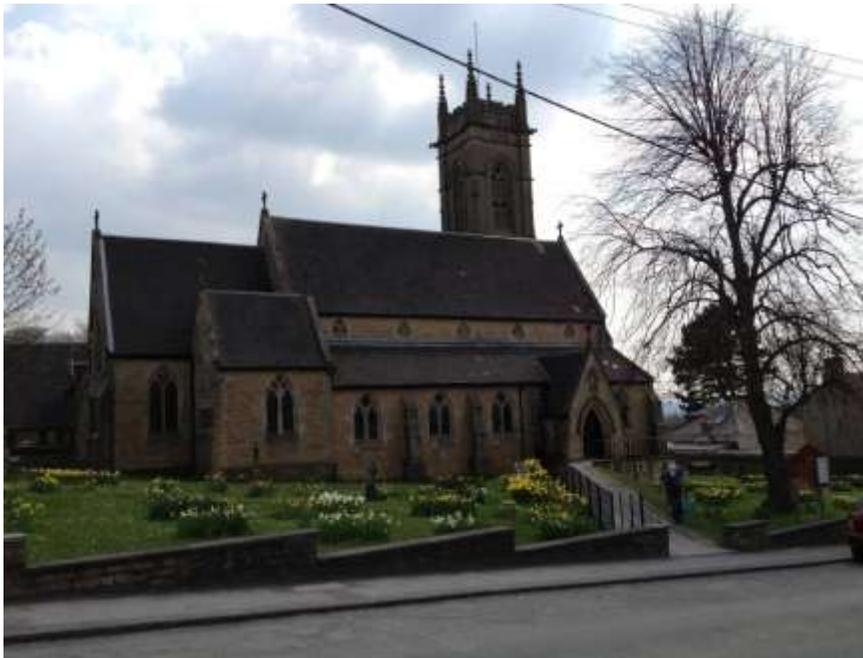
Our Lady Immaculate & St Cuthbert's Church, Church Hill

The convent and church are stone buildings which have been cleaned. The church has a tower with intricately designed pinnacles and is largely in the decorated style. Almost all the residential properties in Church Hill are two storey terraced cottages with stone rubble walls, slate roofs and small front gardens. Mature trees enhance the views along the street and engender the village character of this area. The sequence of views down the street needs to be carried on into the green. At present there is no continuity of views between Church Hill and the green being interrupted by the uninteresting landscape of Crook Beck, the rear of the premises in Mill Street (particularly the garage) and derelict land.

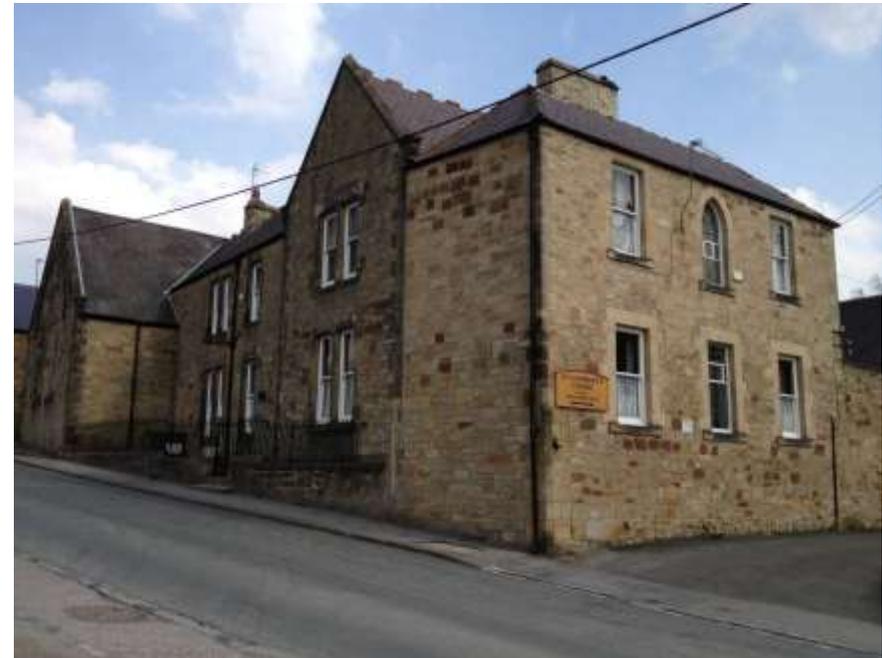
Convent and Community Centre, Church Hill

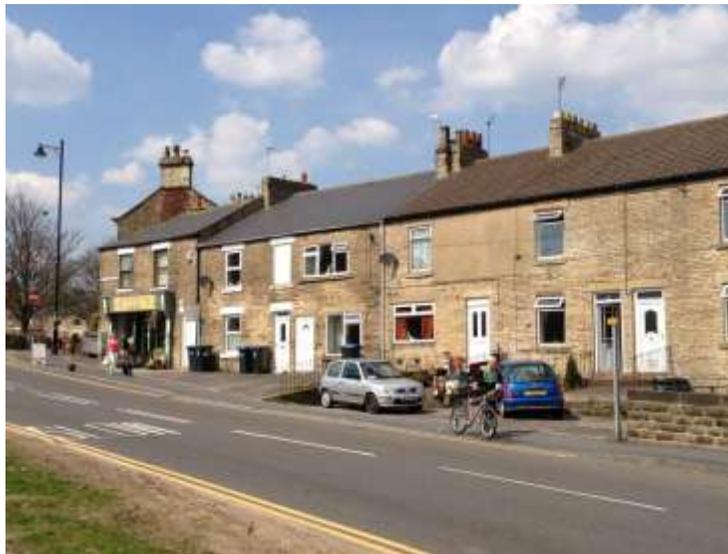
West Bridge Street

West Bridge Street Terrace has a two storey stone frontage and a three storey rear elevation due to a change in the level of the site, adjacent to the Crook Beck. The basement windows in the front elevation have been backed up and several of the properties have had these fenestrations altered, resulting in a general downgrading of the appearance of the terrace. The terrace has considerable potential for improvement, particularly the curtilages. East Bridge Street is a neater row of properties containing a number of commercial premises, these are in varying condition and some would benefit from improvement.

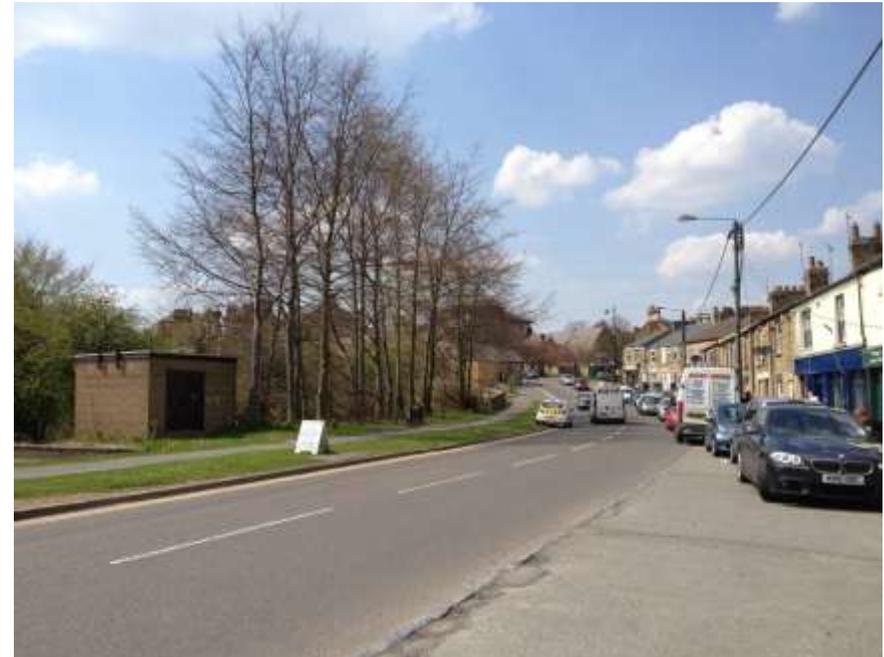
View along West Bridge Street into town centre

detrimental impact upon the townscape. As an entrance to the town centre the area is of poor quality and would benefit from general landscaping and a coordinated approach to improvements of individual buildings. The area also suffers from overhead wires.

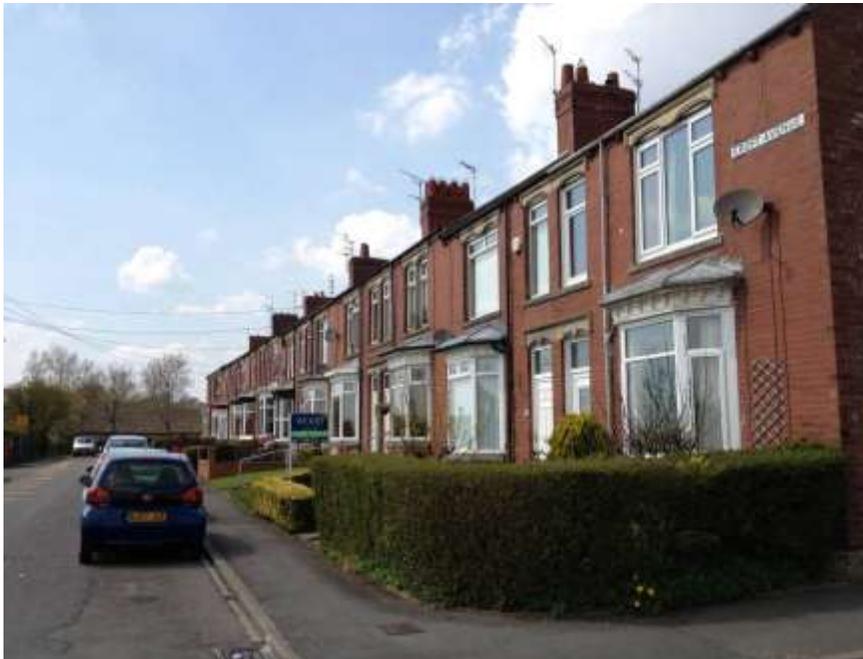
Croft Avenue

Croft Avenue is a cul-de-sac containing a terrace of red brick residential properties with front gardens. A line of bushes and trees at the head of the street provides a stop to views along

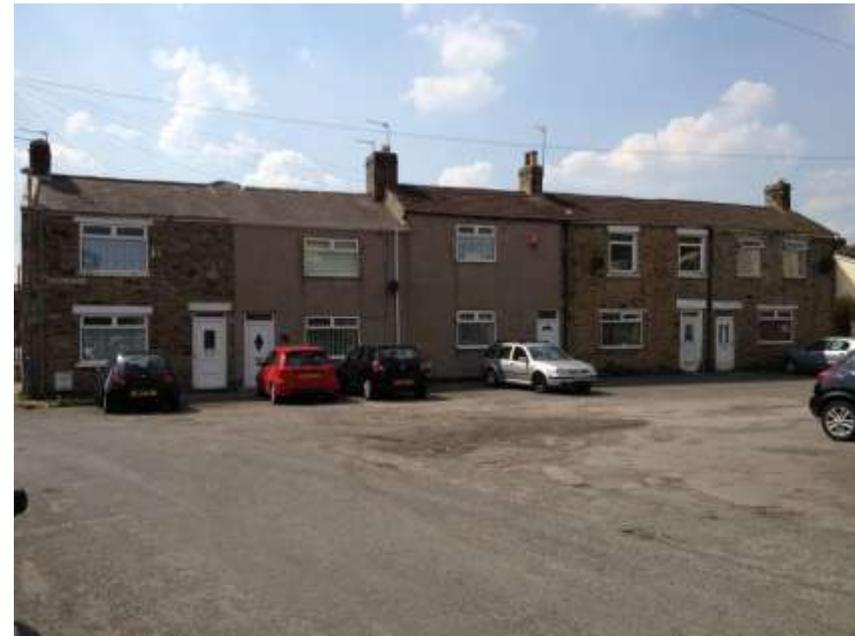
Queen Street

Queen Street contains a terrace of five stone built cottages, whose unity has been partially disrupted through modernisation of some of the properties. At present there is a large tarmac area to the front of the terrace which is bounded by bland walls of warehouses and out buildings and an access lane to the council depot beyond.

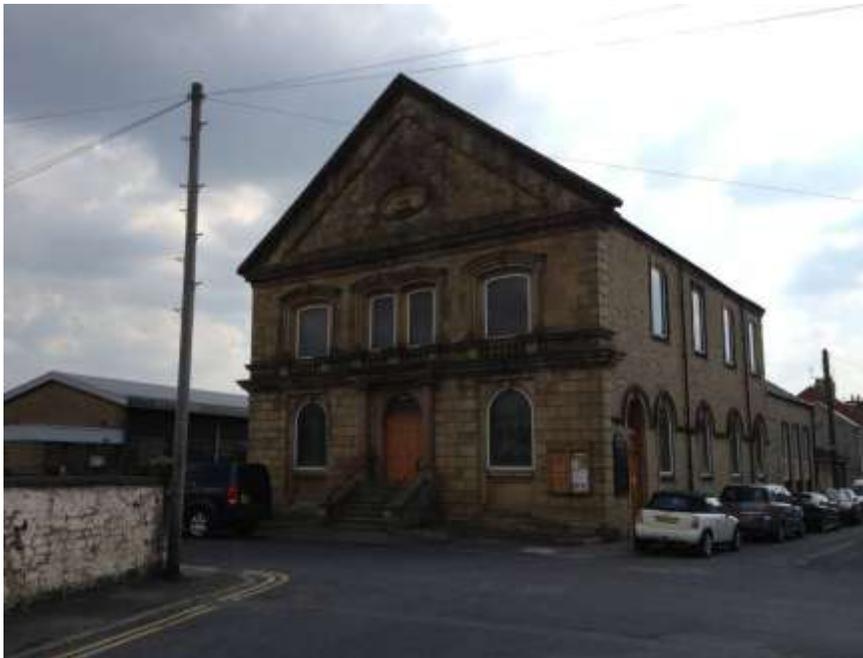
Central Methodist Church, Dawson Street

Primitive Methodist Chapel, named and dated 1868 in pediment. Sandstone ashlar with pink granite columns flanking door; Welsh slate roof. Pedimented front of 2 storeys and 3 bays has moulded plinth; chamfered rusticated ground floor. 8 steps, the top one renewed, to central 4-leaf 8-panelled door and lunette in round-headed moulded keyed surround, recessed between attached columns with stone Corinthian capitals. Keyed, moulded round-headed surrounds to flanking aproned windows recessed in square panels. Double cyma recta ground-floor cornice, breaking forward over door, supports balustrades of first-floor windows, the central paired, which have low segmental heads and cord-moulded surrounds under bracketed drip-moulds with carved central finials. Deeply-moulded pediment on richly-carved cornice has sunken centre containing oval date-panel with cord-moulded frame and lily finial. Roof has 2 ogee-stopped ridge ventilators. Dwarf walls flanking steps have chamfered coping; wrought-iron handrails have down-curved ends. Interior: painted plaster above boarded dado; slender cast-iron columns with crocket capitals, support continuous gallery on 3 sides, with cast-iron bombe balustrade which has ivy-leaf decoration in 4 petals on circle motif; similar more slender posts in gallery. Large panelled pulpit with side steps in front of organ which is set in moulded arch on Corinthian pilasters. Flanking panelled wood screens to minister's and choir's vestries. Iron balustrades on rear gallery stairs in entrance foyer with tiled floor. Ceiling with moulded decoration is deeply coved along the long axis; 3 ceiling

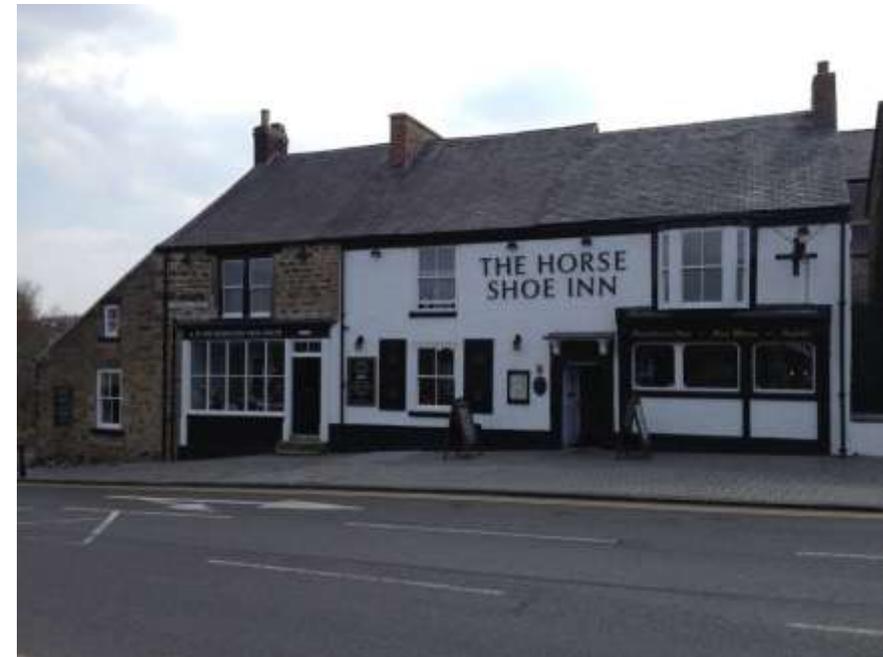
Ye Olde Horse Shoe Inn, Church Street

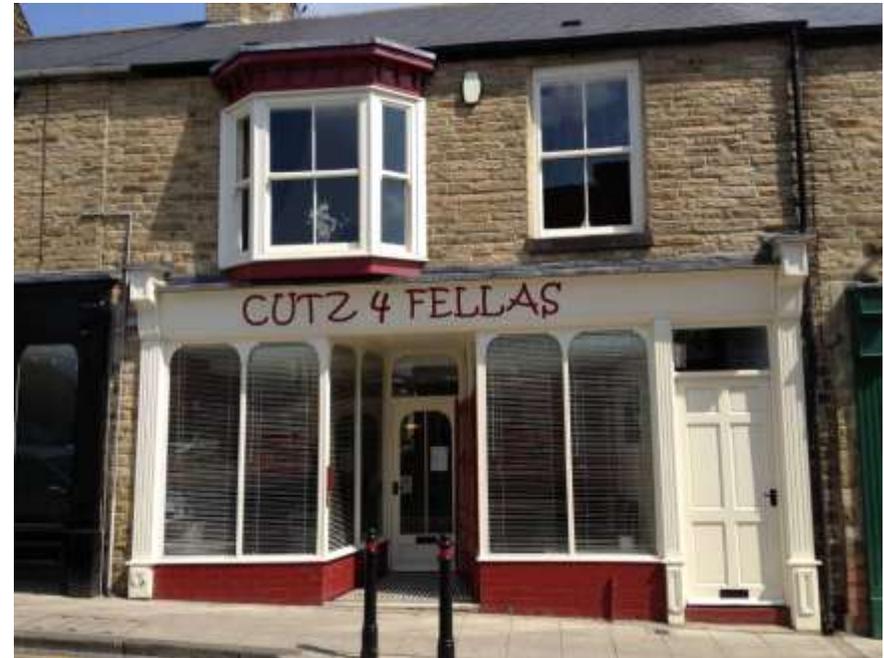
Traditional shop front on Hope Street

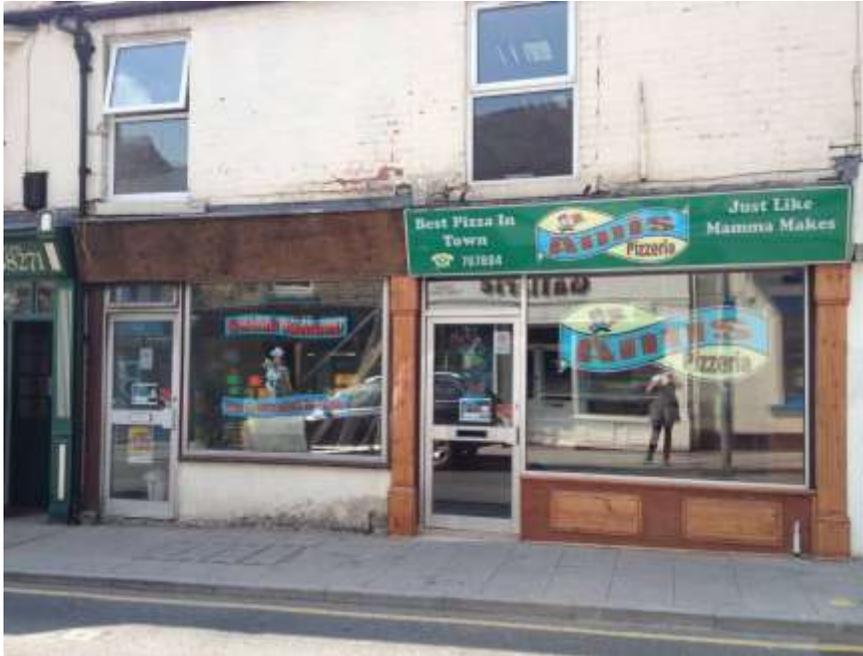
Whilst some original timber shop fronts have been retained and replicated throughout the conservation area, there are a number of inappropriate modern shop fronts and signage which detract from the character of the area.

Modern shop fronts on Hope Street

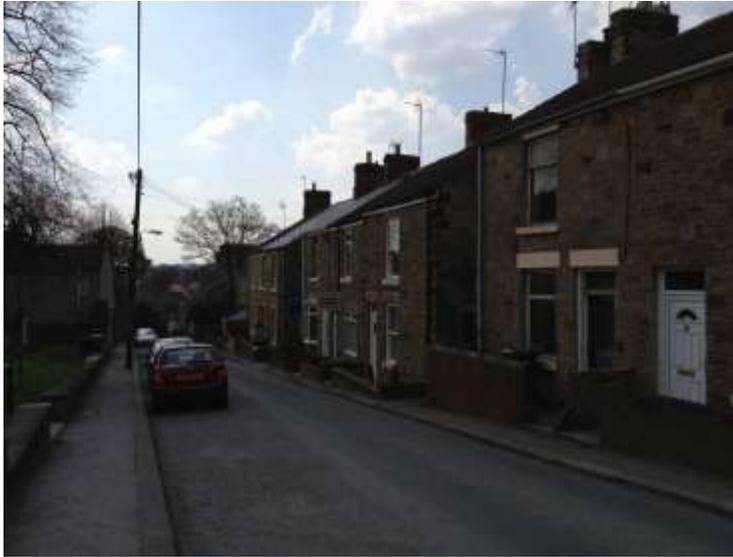
View down Church Hill
